Building Envelope Test – Straw Bale Construction, Nevada City CA

Presented By:
Sierra Energy Professionals
P.O. Box 4112
Truckee, CA 96160

Millette Residence

**19480 Chalk Bluff Rd.
Nevada City, CA 95959**

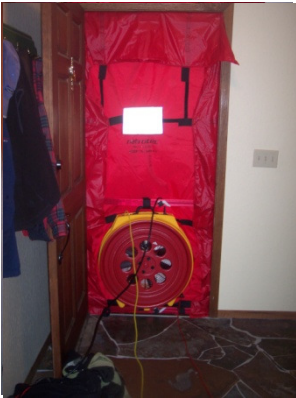
Figure 1: Blower Door setup.

Depressurization: A Blower Door test (**Figure 1**) was set up on the front door, with the fan set to depressurize the interior of the house to negative 50 Pascals(Pa) relative to the exterior. This approximates a 20 mph wind hitting the house on all sides and causes air to infiltrate from the exterior to the interior living space.

When the house pressure was at a 50 Pa difference relative to the exterior, the flow of air infiltrating from outside into the building envelope was measured to be **617 cubic feet per minute (CFM)**. This is the **equivalent of an 81 square inch (less than 1 square foot)** window being open on a flat wall all the time. This is a very low number and no improvements are seen as necessary in this area. The American Society of Heating, Refrigeration, and Air Conditioning Engineers (ASHRAE) suggest a minimum natural ventilation of 950 – 1,200 CFM for a house of this size. This house is tighter than ASHRAE suggests without mechanical ventilation but occupant knowledge and behavior surpasses any need for that.

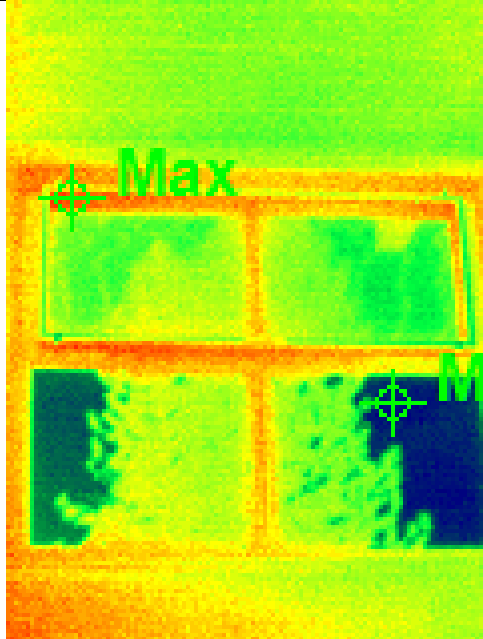
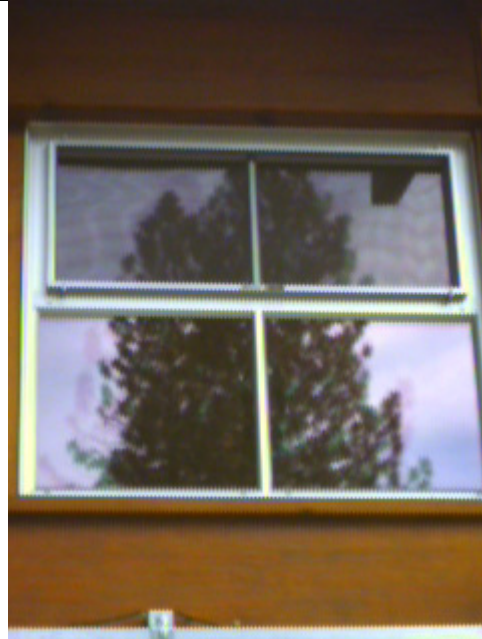
Figure 2b: Visual Image

Figure 2a:
Infrared Image
Windows on south side of house above sliding glass door from exterior. Only thermal movement is from bridging across frame. Very well sealed window.

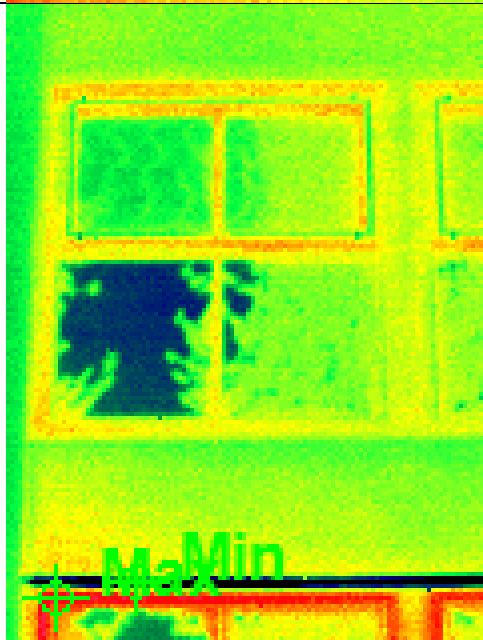
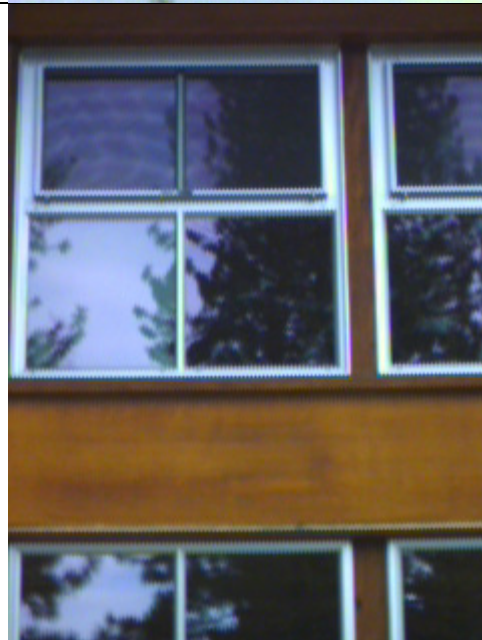
Figure 3b: Visual Image

Figure 3a:
Infrared Image
windows to right of sliding glass door. No air leakage.

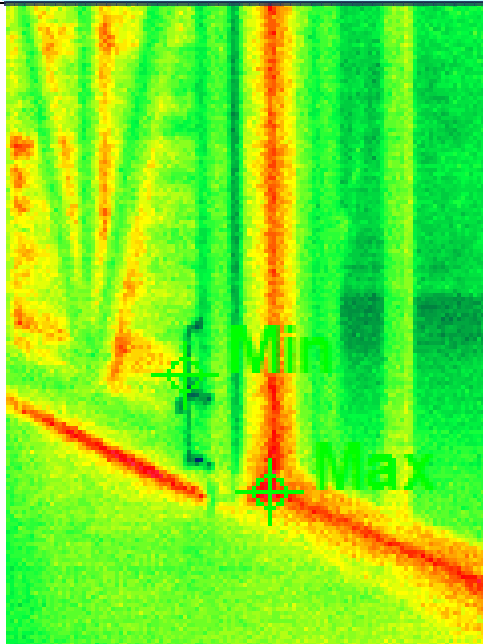
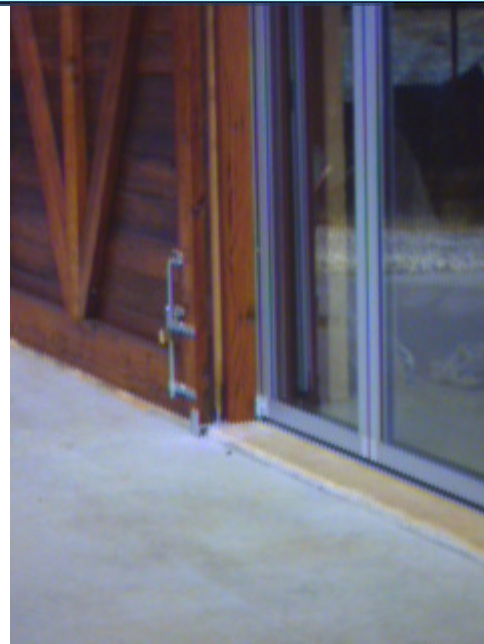
Figure 4b: Visual
Image

Figure 4a:
Infrared Image
sliding glass door.
Minor air
movement around
edges especially
left side. Other
thermal
movement due to
radiant heat.

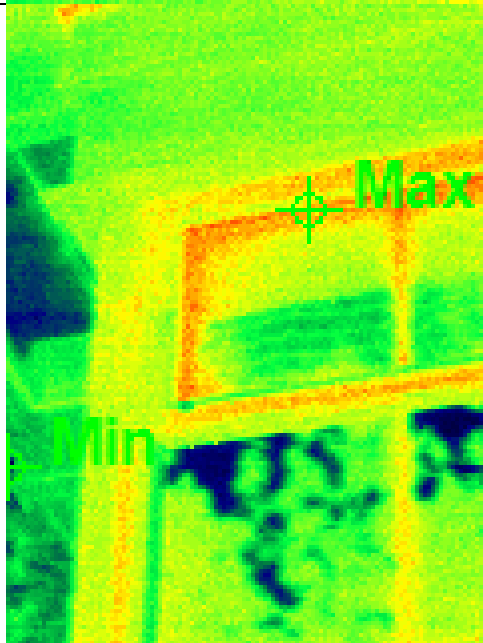
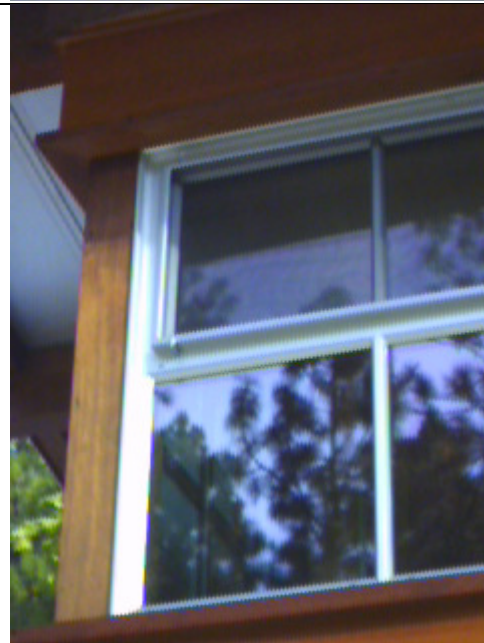
Figure 5b: Visual
Image

Figure 5a:
Infrared Image
exterior corner of
"bed nook".
Looks very good
basically no
leakage

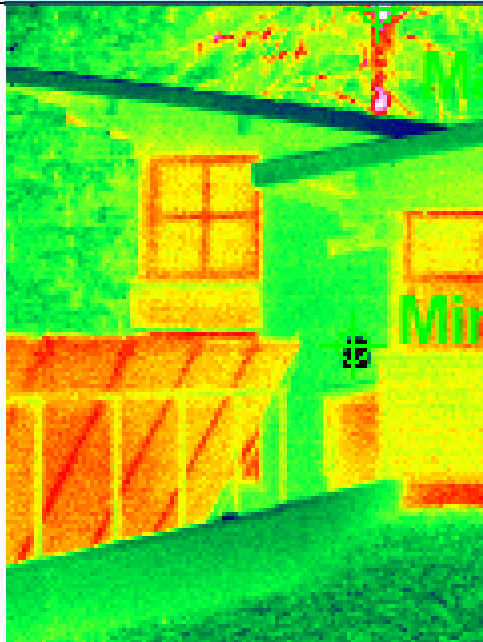
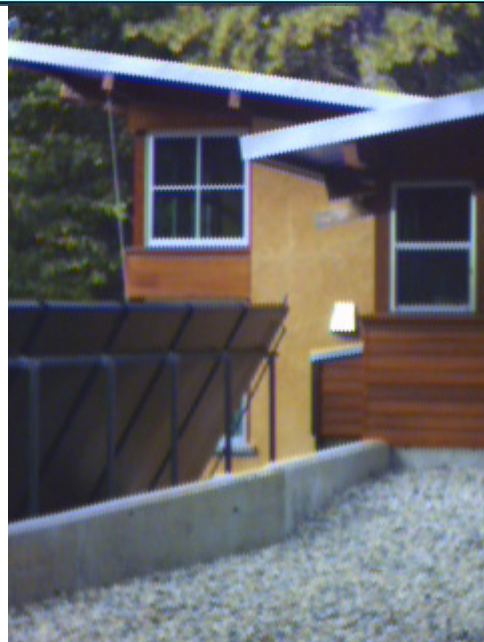
Figure 6b: Visual Image

Figure 6a:
Infrared Image exterior of house looks very good. Possible leakage or bridging in bottom right from foundation connection of bathroom.

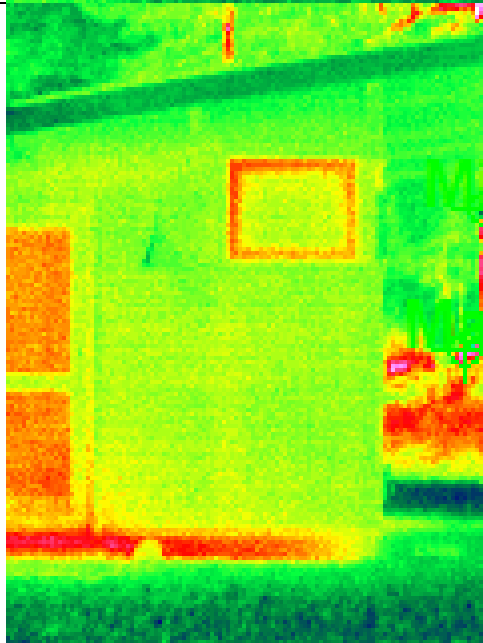
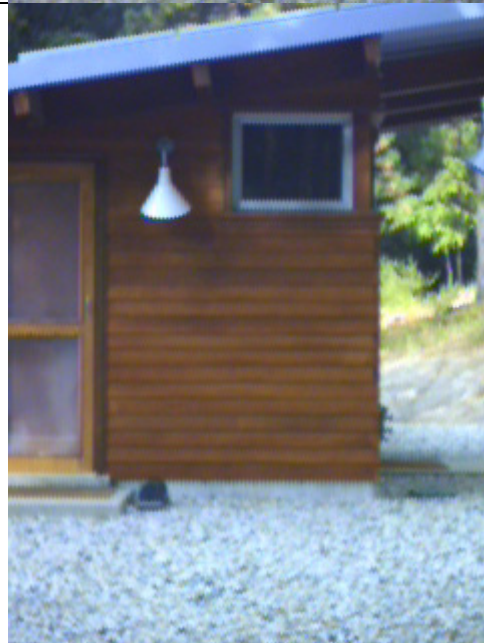
Figure 7b: Visual Image

Figure 7a:
Infrared Image bathroom no air leakage just bridging from foundation.

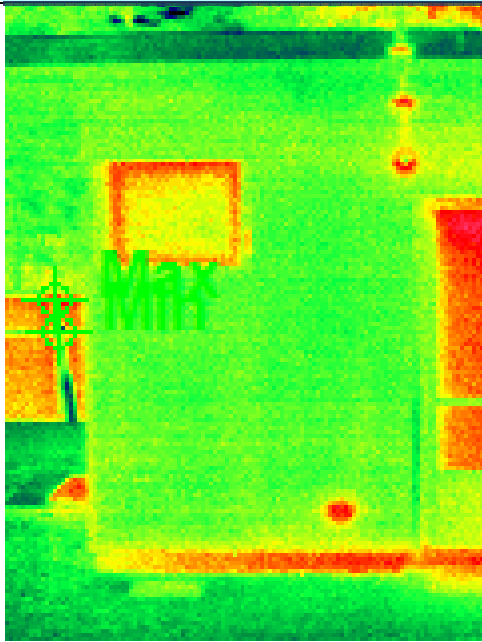
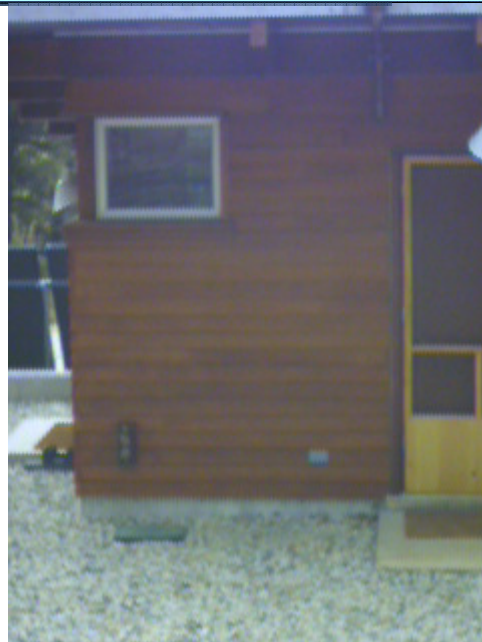
Figure 8b: Visual Image

Figure 8a: Infrared Image front door. Possibly some leakage from penetration to upper left of door. Everything else good.

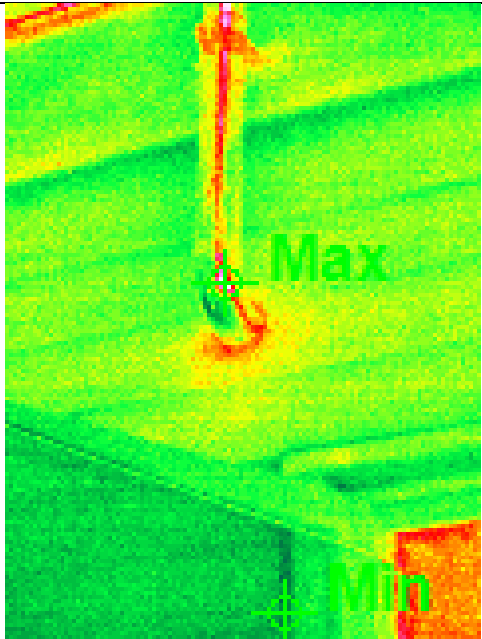
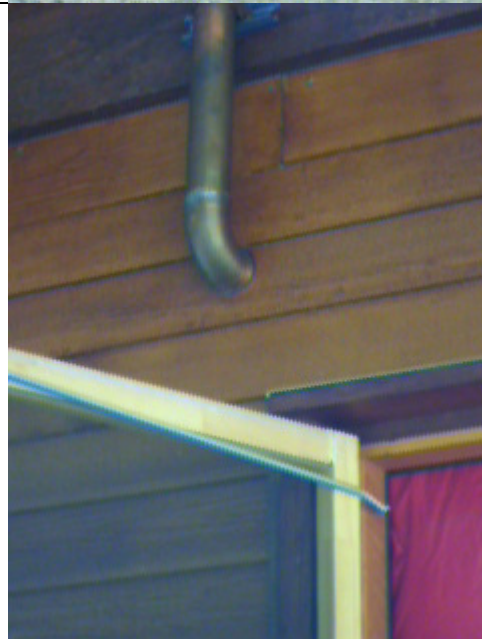
Figure 9b: Visual Image

Figure 9a: Infrared Image pipe penetration above front door. Probably residual heat from venting, could be minor infiltration issue.

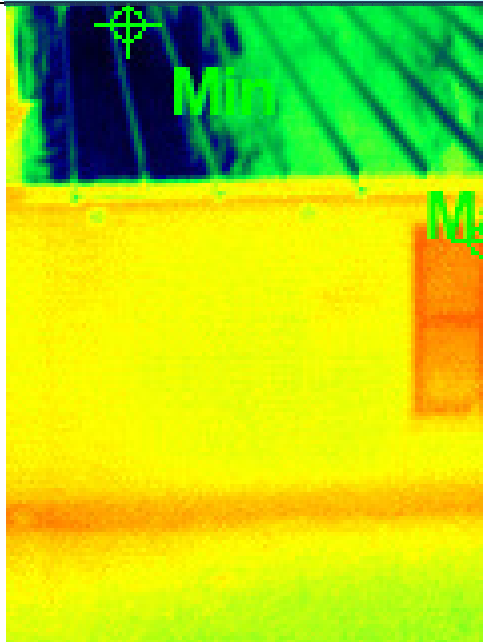
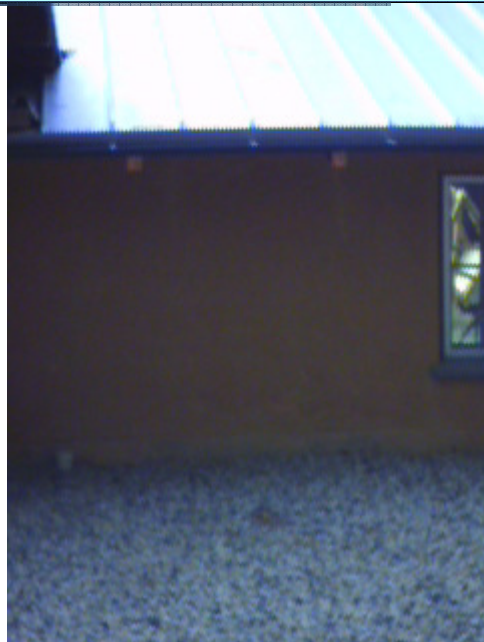
Figure 10b:
Visual Image

Figure 10a:
Infrared Image
north wall looks
good. Note lack
of bridging at
foundation.

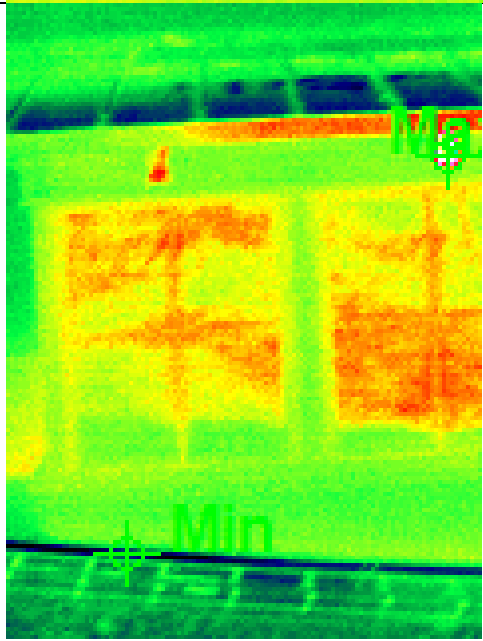
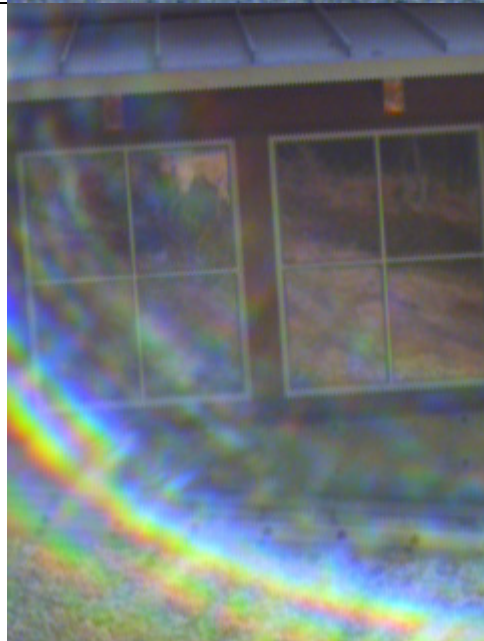
Figure 11b:
Visual Image

Figure 11a:
Infrared Image
west side of
house. Red up
higher is heat gain
from the sun.

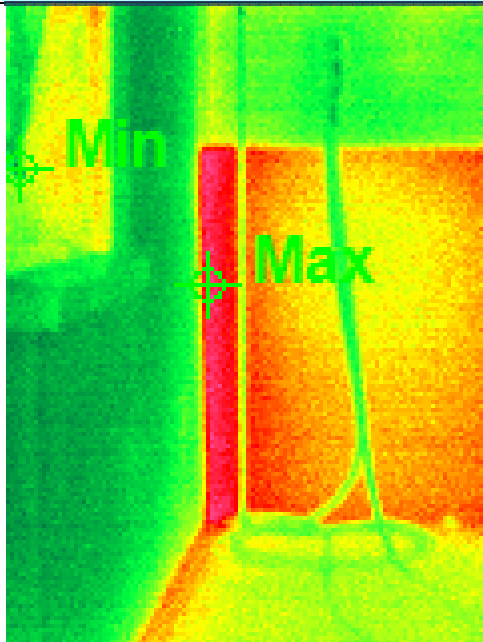
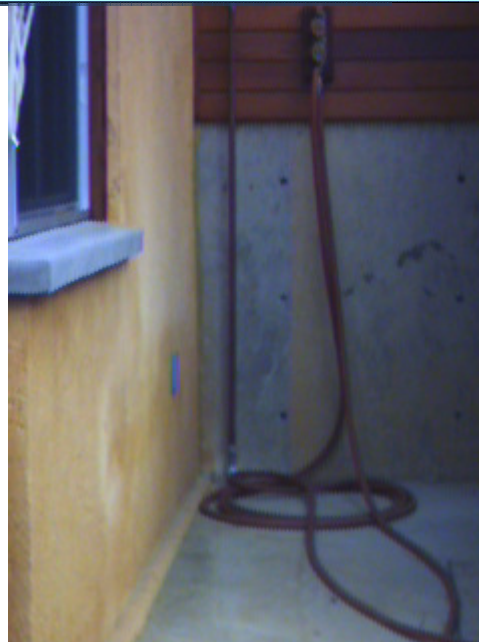
Figure 12b: Visual Image

Figure 12a: Hot water distribution visible in wall behind hot water solar panels. Mechanical room on other side pumps hot water down that corner.

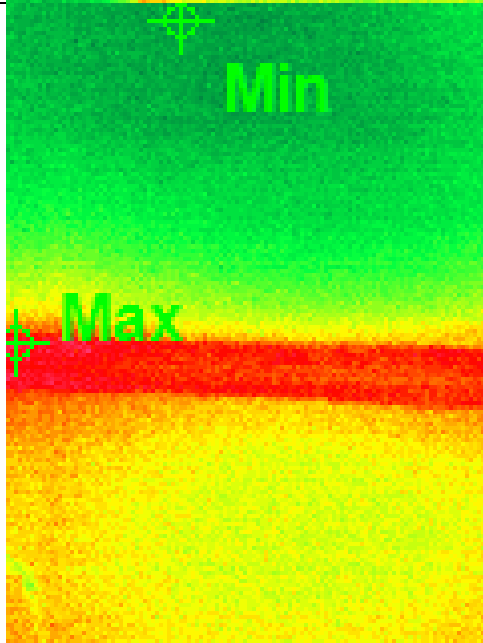
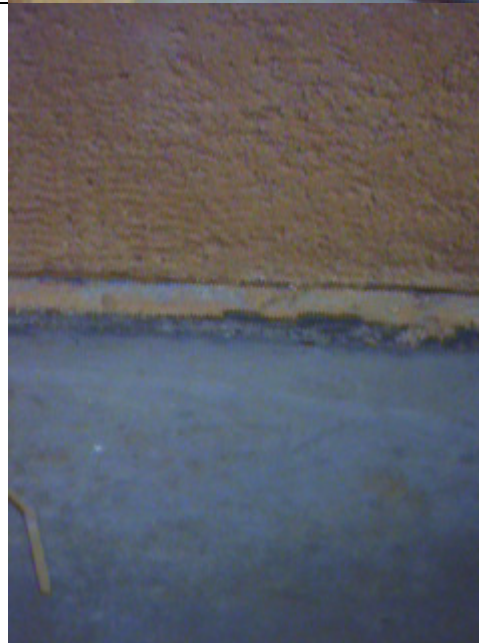
Figure 13b: Visual Image

Figure 13a: Infrared Image heat escaping through the foundation slab. Even though it is insulated from the hydronic section it still provides a thermal bridge to the exterior.

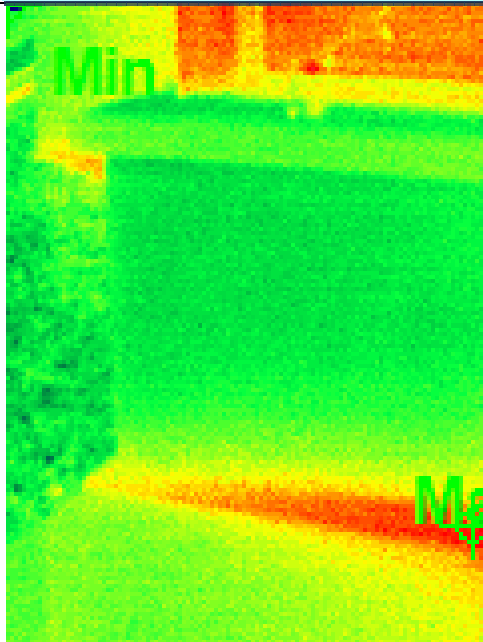
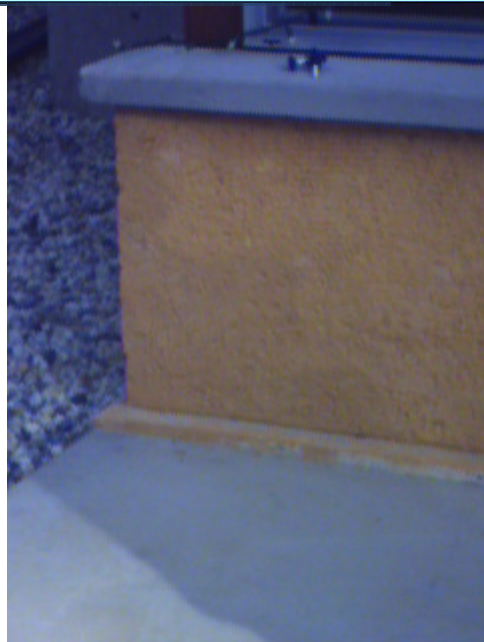
Figure 14b:
Visual Image

Figure 14a:
Infrared Image of corner by "bed nook". Note foundation bridging.

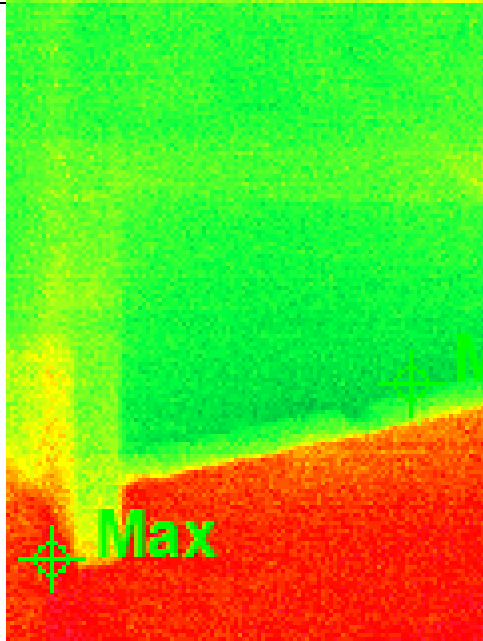
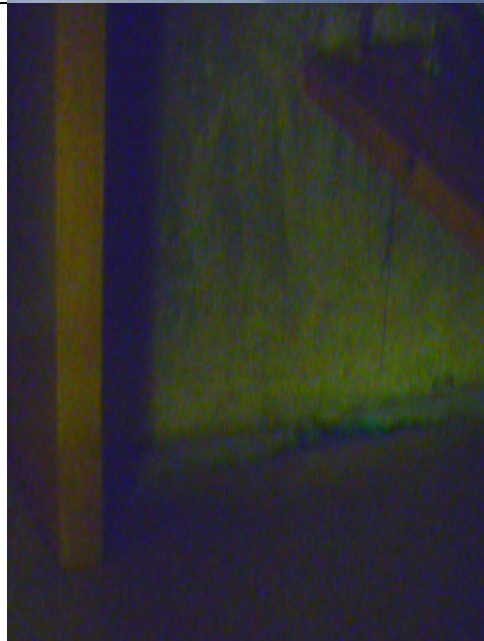
Figure 15b:
Visual Image

Figure 15a:
Interior floor edge by refrigerator. No bridging from floor to exterior foundation visible, but not exposed on exterior like other areas.

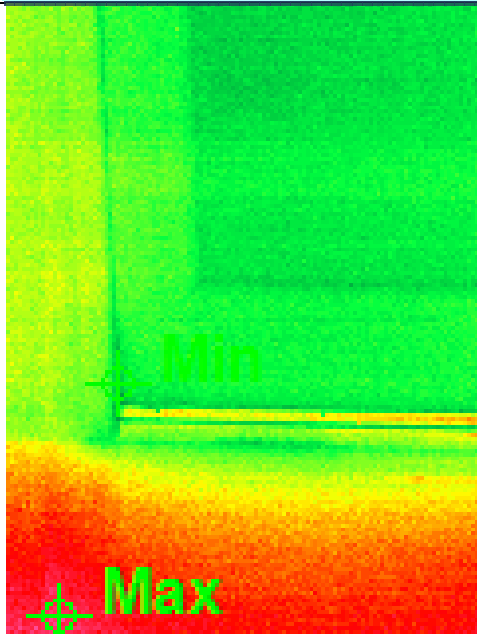
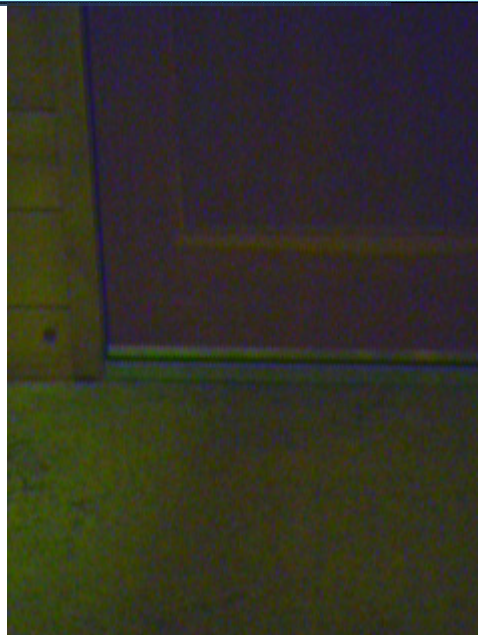
Figure 16b:
Visual Image

Figure 16a:
Infrared Image
door from
bathroom to
exterior before
Blower Door test.

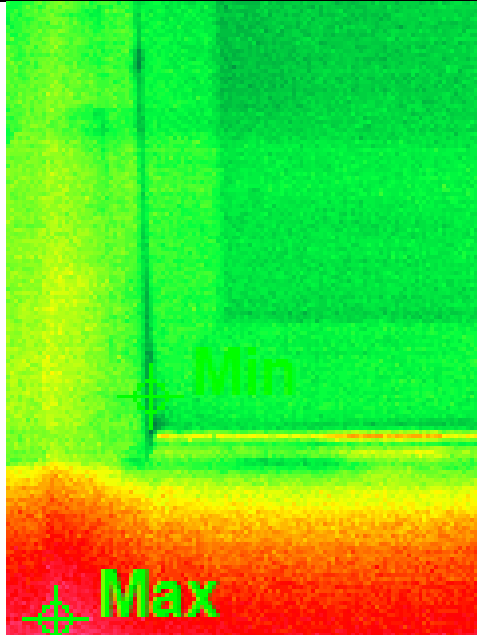
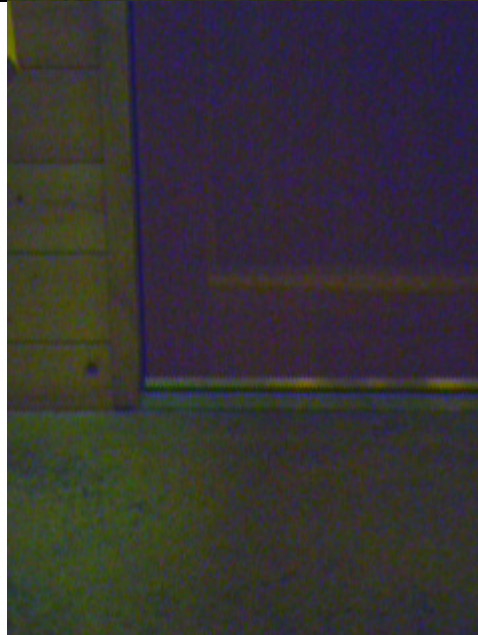
Figure 17b:
Visual Image

Figure 17a:
Infrared Image
bathroom door at
very start of
Blower Door test.

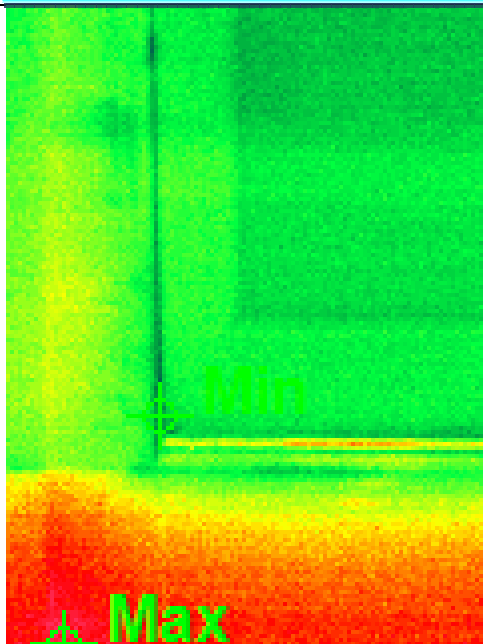
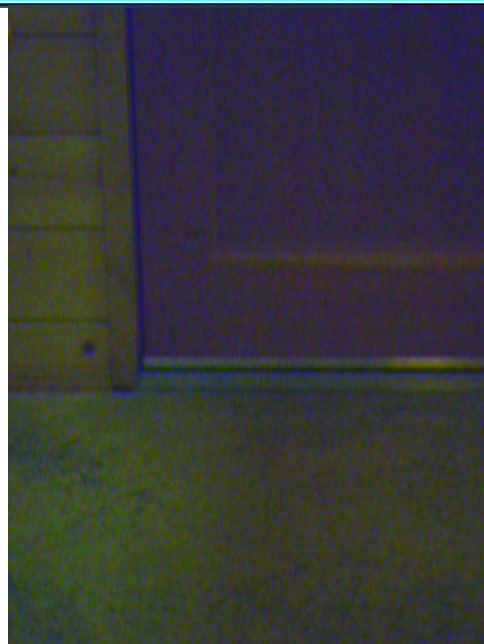
Figure 18b:
Visual Image

Figure 18a:
Infrared Image
bathroom door
after 5 minutes of
Blower Door
testing. Note very
slight growth of
blue line on left
side of door, this
is a well sealed
door.

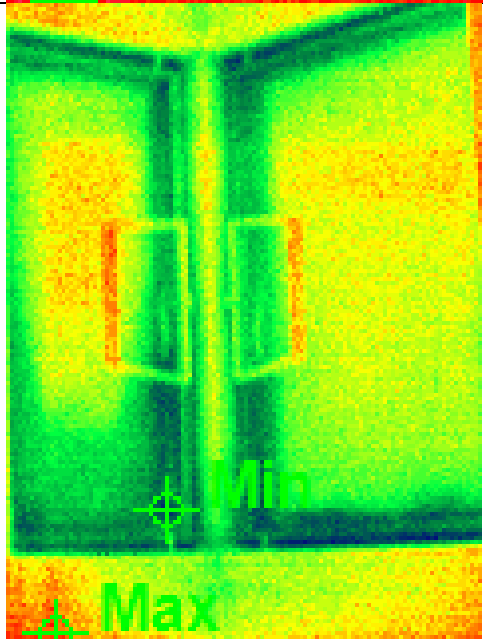
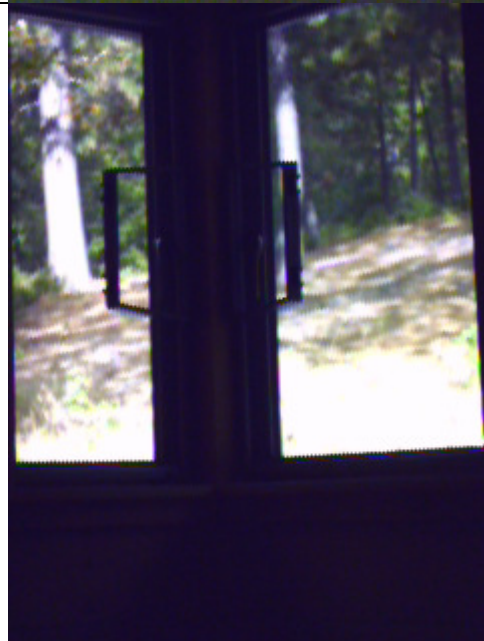
Figure 19b:
Visual Image

Figure 19a:
Infrared Image
entryway
windows no
apparent leakage
just thermal
bridging.

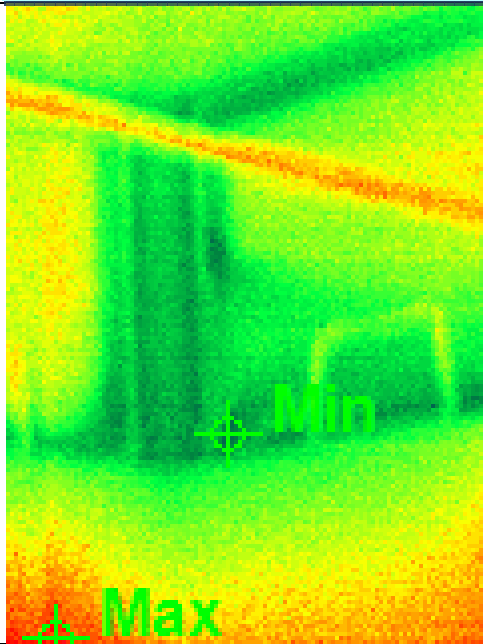
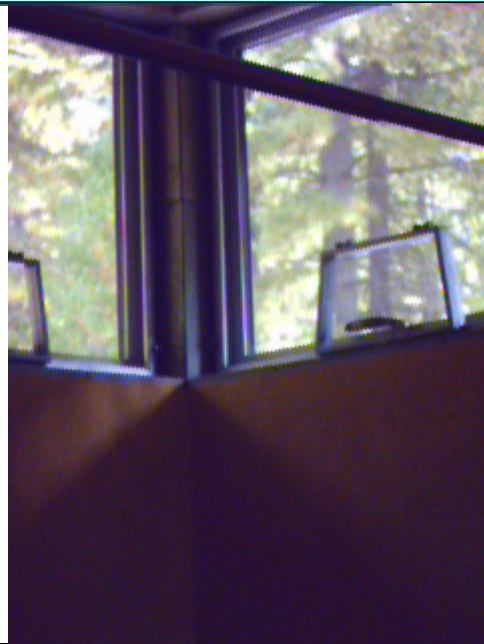
Figure 20b:
Visual Image

Figure 20a:
Infrared Image
bathroom
windows. Look
good no
infiltration.

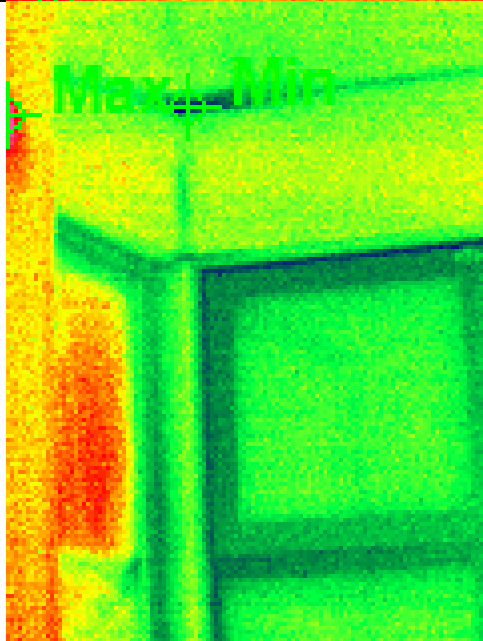
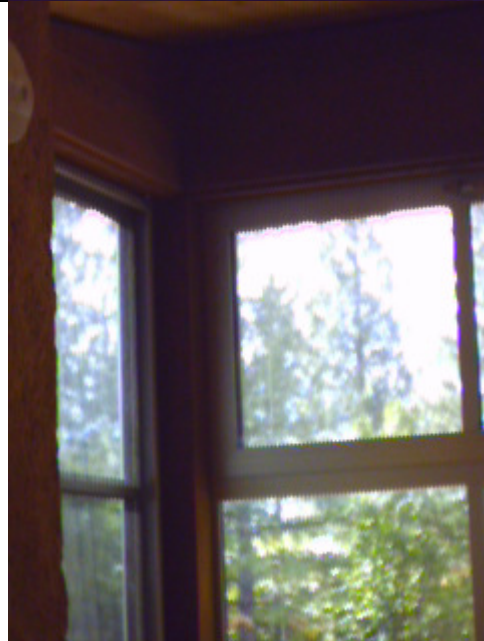
Figure 21b:
Visual Image

Figure 21a:
Infrared Image
loft windows.
Note area of
infiltration in top
left corner. A gap
was seen on close
visual inspection.

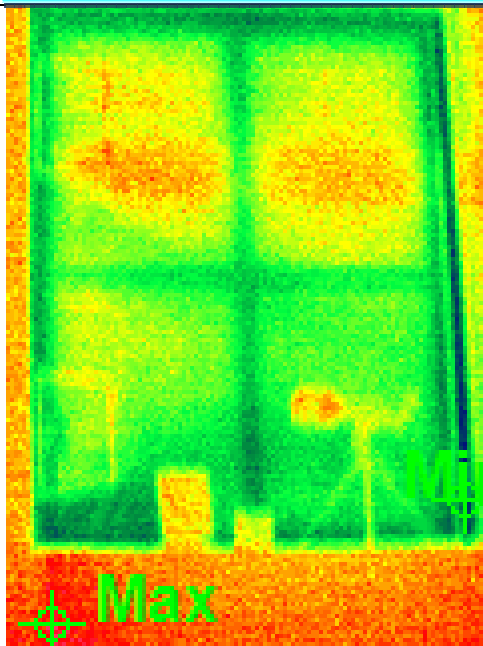
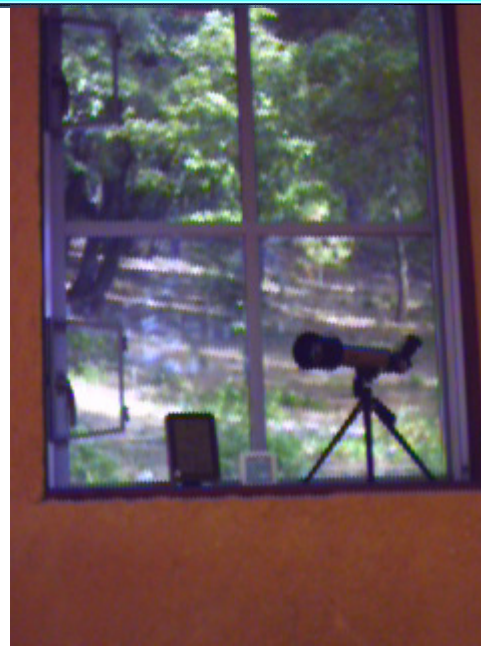
Figure 22b:
Visual Image

Figure 22a:
Infrared Image
living room
window. All
thermal bridging
transfer.

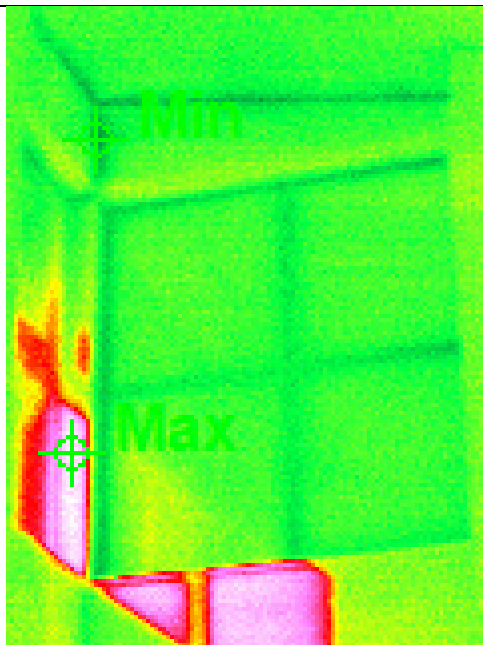
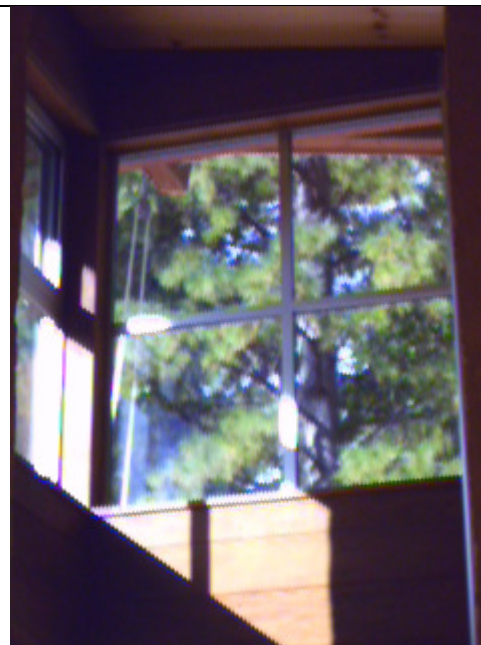
Figure 23b:
Visual Image

Figure 23a:
Infrared Image
upper corner
living room
windows. Heat is
due to sun
warming. Note a
bit of infiltration
in upper corner at
wall/ceiling
interface.

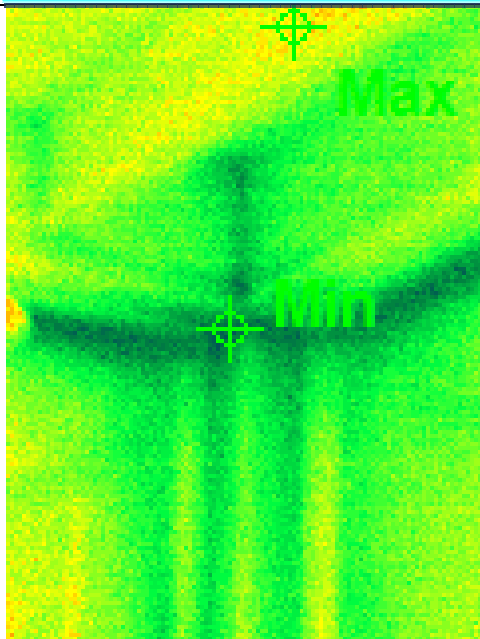
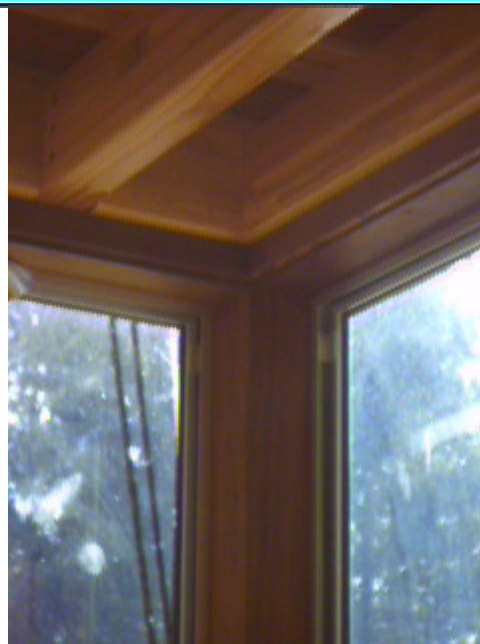
Figure 24b:
Visual Image

Figure 24a:
Infrared Image
upper corner
kitchen windows.
Possibly some
leakage along
joints and up into
corner.

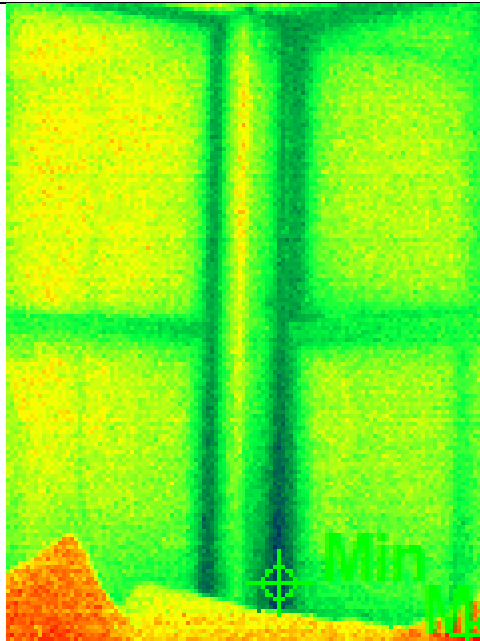
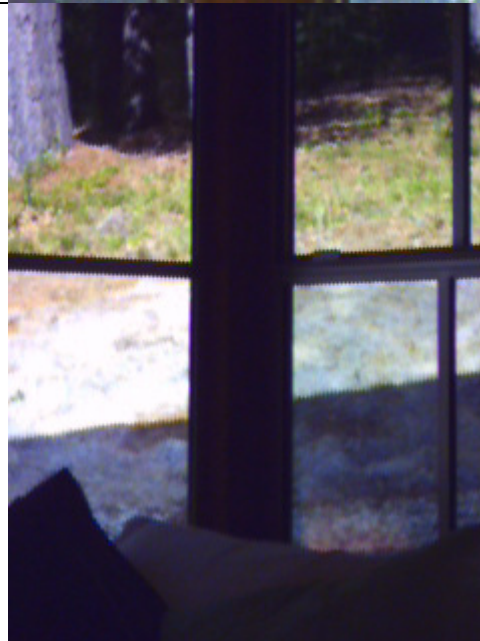
Figure 25b:
Visual Image

Figure 25a:
Infrared Image
"bed nook"
windows. Look
good.

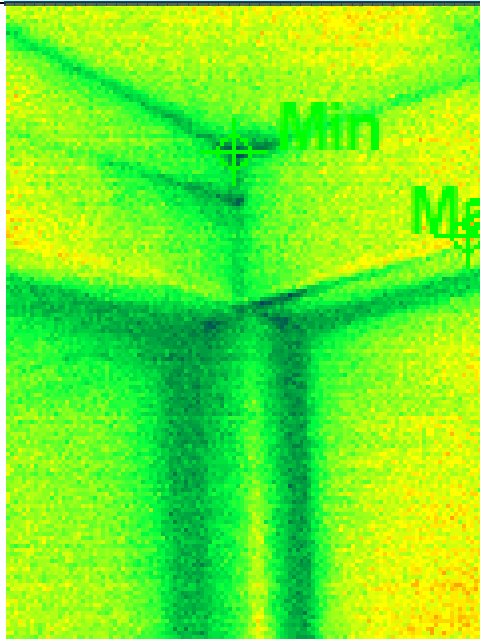
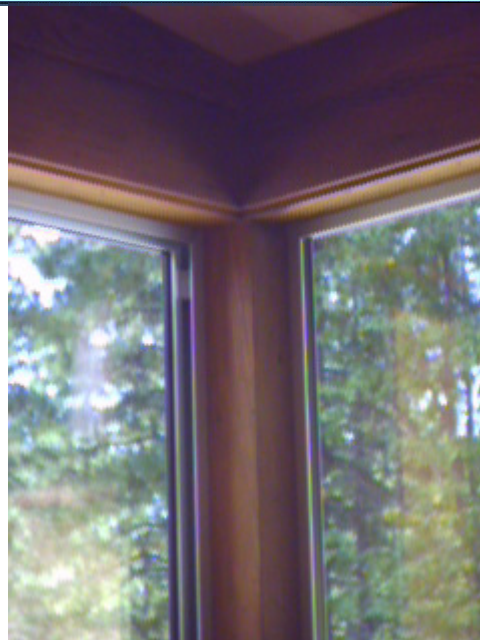
Figure 26b:
Visual Image

Figure 26a:
Infrared Image
"bed nook
windows".
Corner might
show some
infiltration.

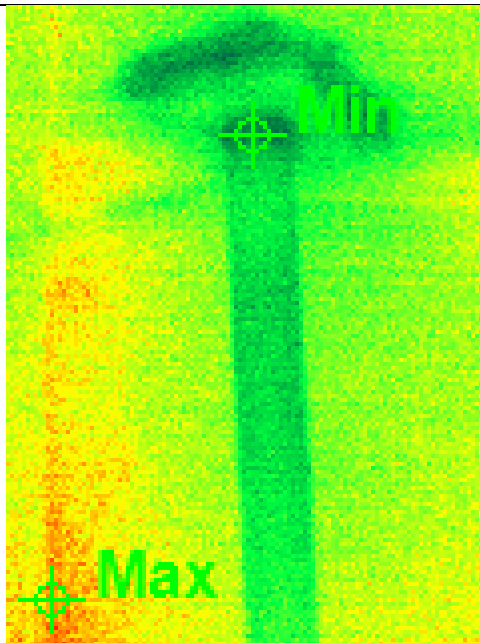
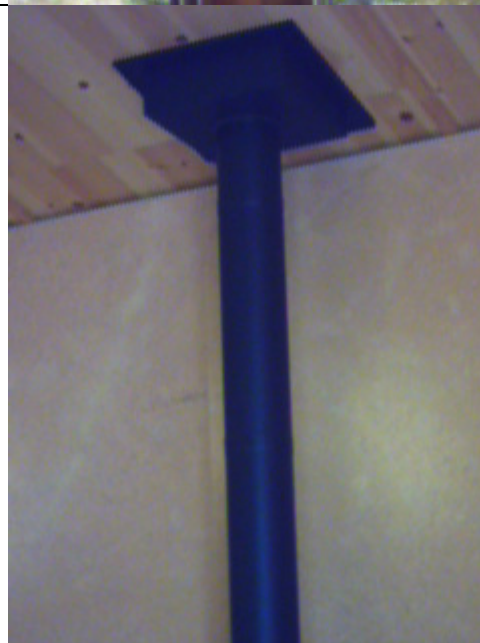
Figure 27b:
Visual Image

Figure 27a:
Infrared Image
well sealed
chimney flashing
some radiative
transfer.

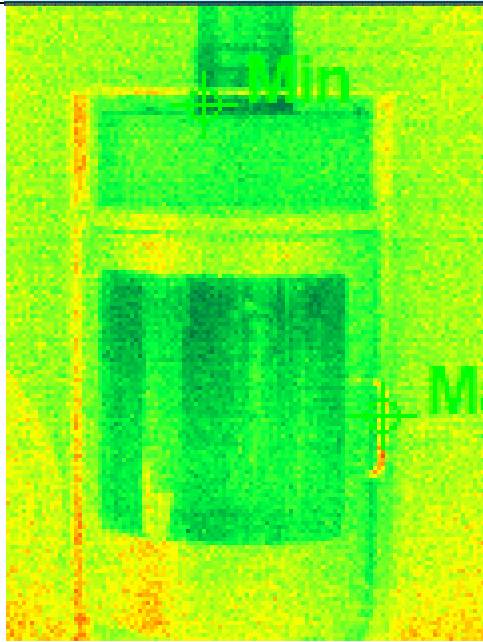
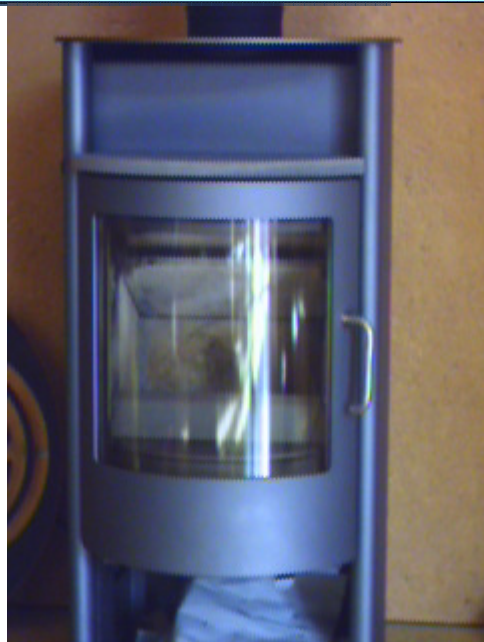
Figure 28b:
Visual Image

Figure 28a:
Wood burning stove. Leakage from flue is basically unavoidable, good shielding at chimney helps.

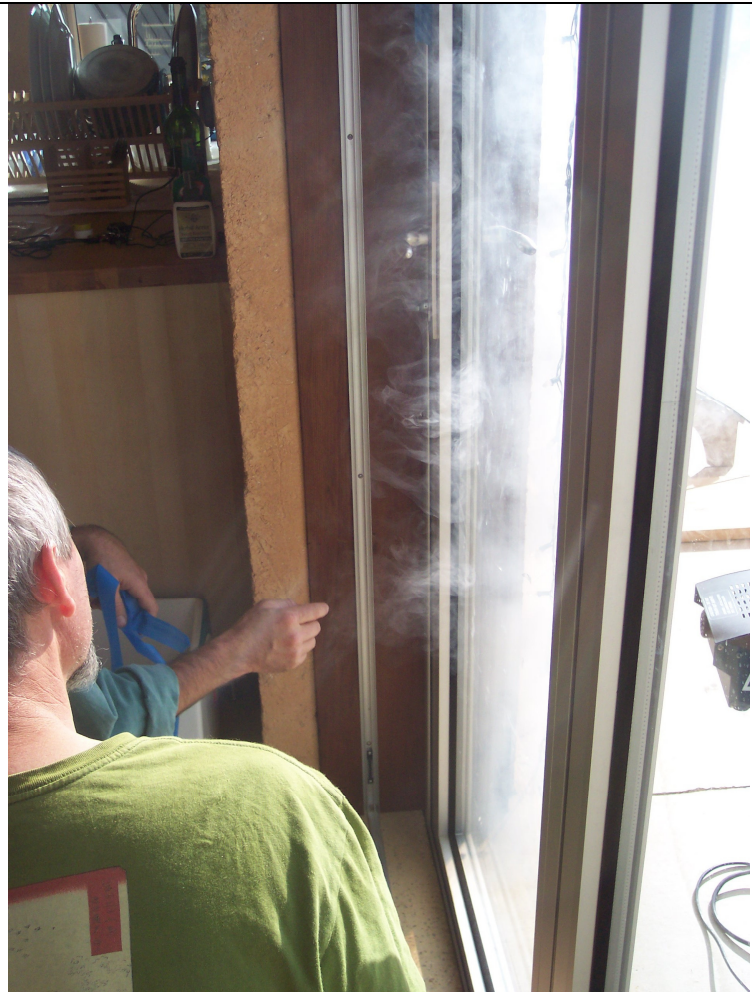
Figure 29: Very minor infiltration of fog in bottom right corner of right window during house depressurization.
