Fire-Resistive Strawbale Walls Survive North Bay Wildfires

While architects and builders have known for years that the strawbale walls of their buildings have superior fire-resistance, several examples of homes surviving recent wildfires bear further evidence of this quality.

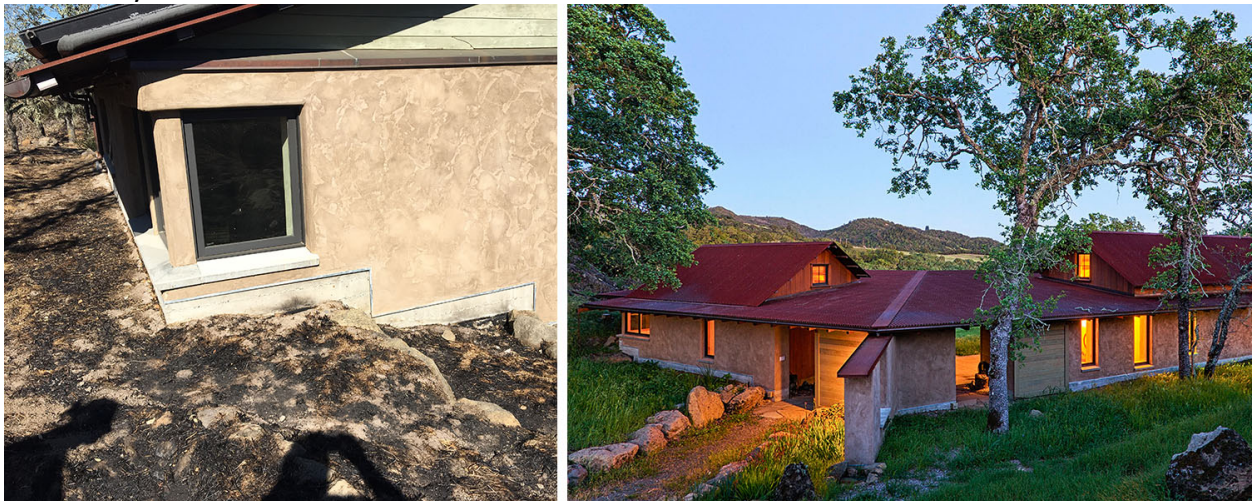
fig.1. Norrbom Road Strawbale Home - fires burned to the foundation on but not up the walls.

This strawbale home that survived is located near the end of Norrbom Road, north of the City of Sonoma. The [residence](#) features strawbale walls coated in Natural Hydraulic Lime plaster, rusted metal roofs and a concrete terrace adjacent the wood frame walls. While the fires burned up to the plastered bale walls, and charred a sliding wood door, the home did not catch fire. The owner stated,

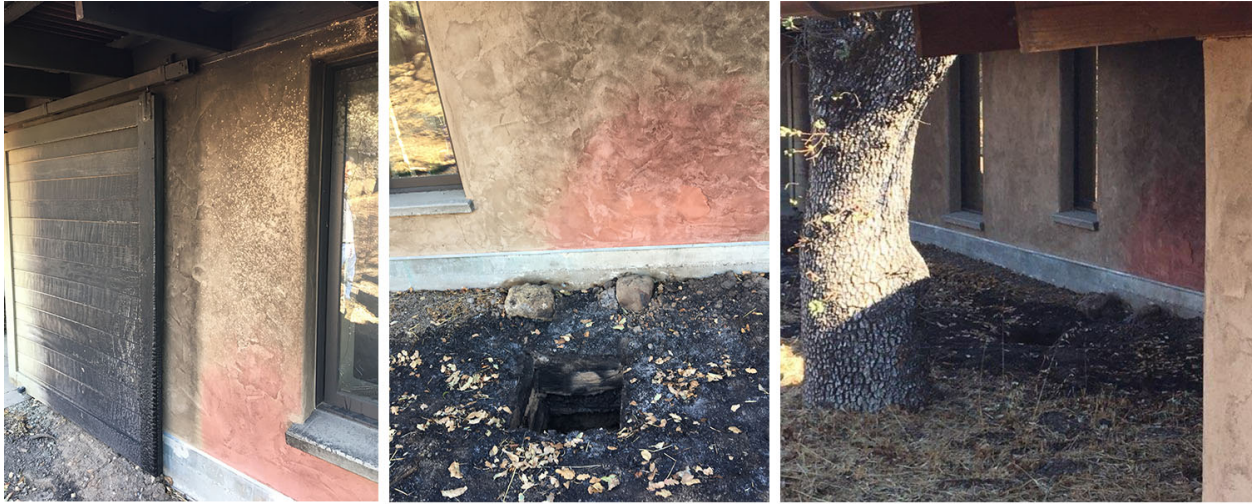
fig. 2. Norrbom Road - Mineral oxides in Natural Hydraulic Lime turn pink when heated.

Michel Couvreur of TransMineral, purveyors of the Natural Hydraulic Lime used to plaster the walls of the home, noted that the pink hue is the result of the heat of the fires drawing out iron oxides from the mineral impurities in the lime mix, and that they use heat to create some of the colors. He added that the walls suffered no permanent damage and should be serviceable well into the future. Michel provided CASBA with these photos of the home after the fire.

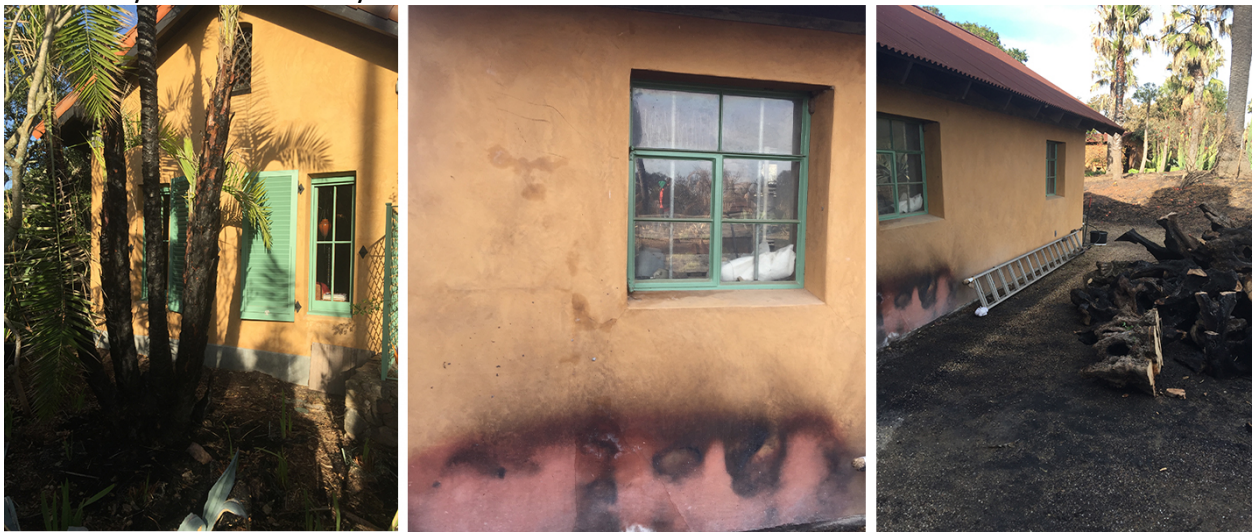
fig.3. Strawbale home on Lovall Valley Loop Road withstood fire against its walls.

"I am very happy to report that I spoke with the owner of the Napa house as the fire was approaching, (he got out in time and called me back a few days later). Apparently half of [the] landscaping was destroyed and the fire burned for quite some time with the flames hitting the walls and eave of the house. He had several oak trees that were in direct contact with the walls, resulting in NO defensible space. He reports no damage to the house, not even a broken window where the flames clearly burned for some time. Ray Cole believes that the 14" inset protected the glass as the flames tend to go vertically once they hit a wall. His two nearest neighbor's houses burned to the ground."

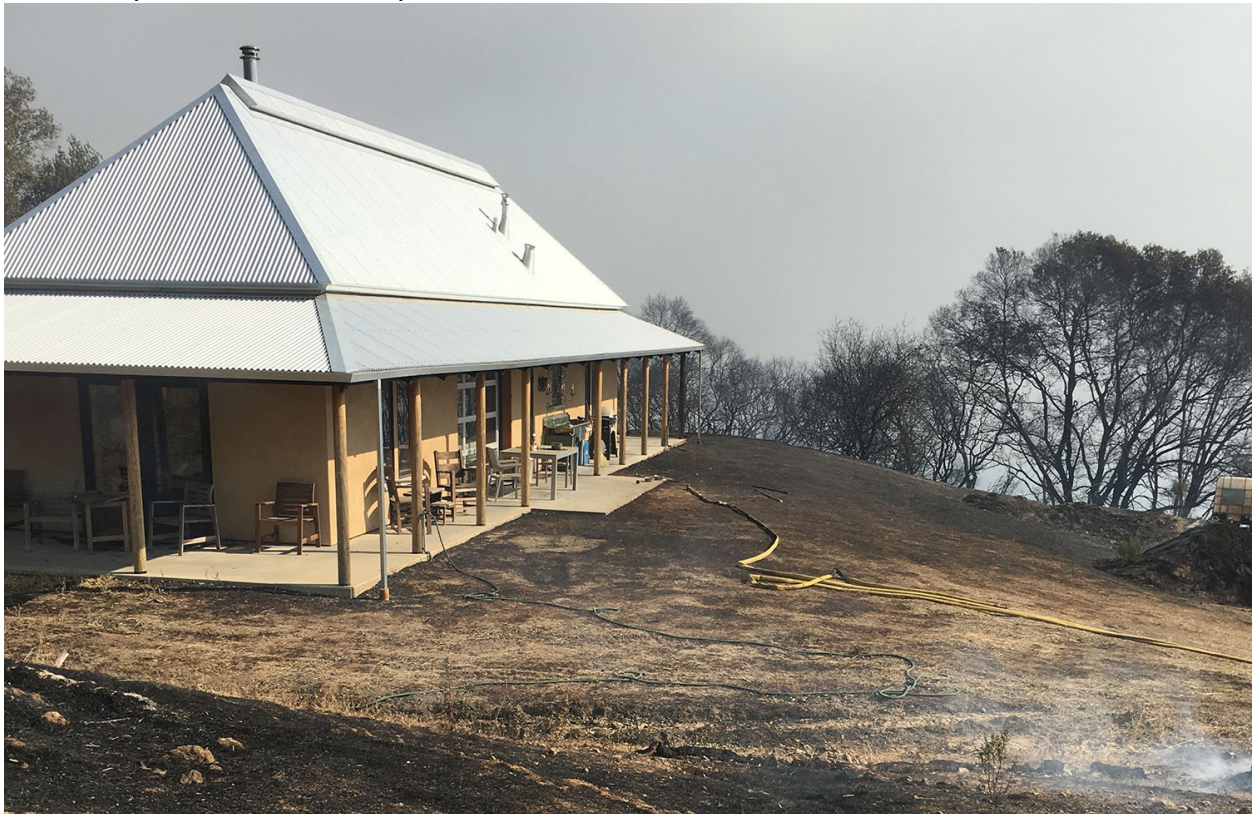
fig. 4. Redwood Valley Residence - trees, outbuildings and two neighboring homes burned.

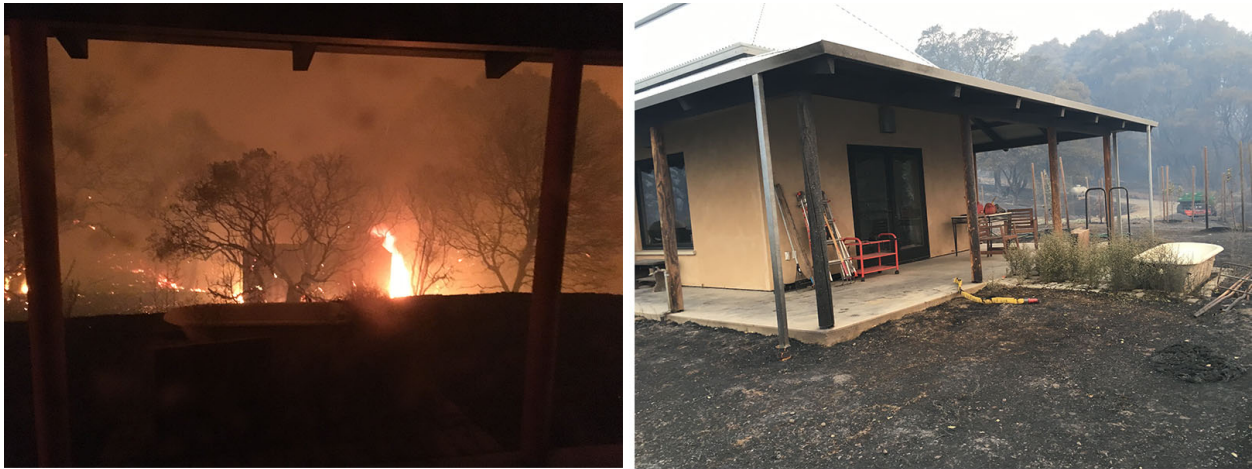
fig. 5. Redwood columns salvaged from a prior fire frame the conflagration; charred but did not ignite.

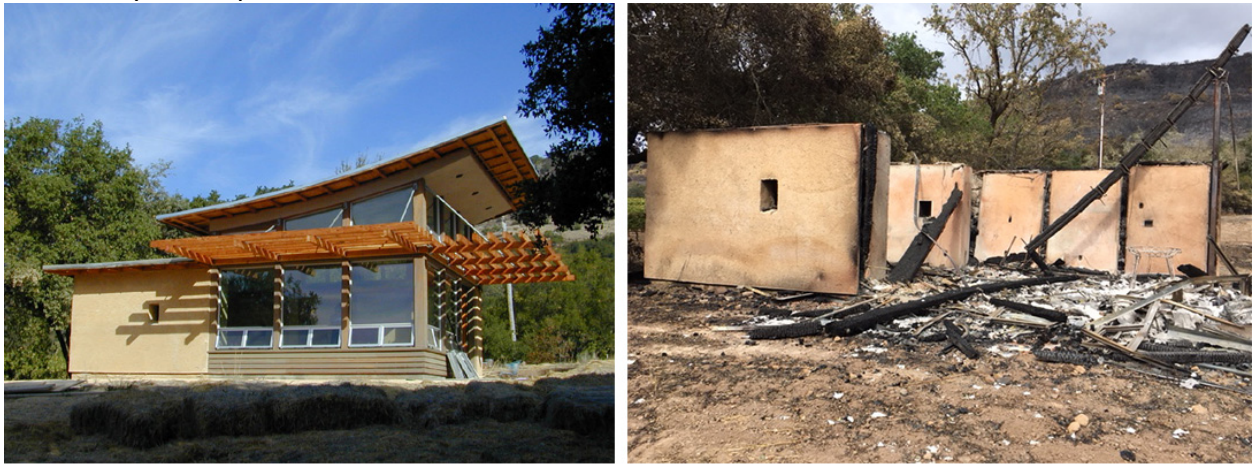
fig. 6. Napa Studio burned in the Atlas Fire; strawbale walls burned after the roof above was breached.

A remote one-room studio with strawbale walls on three of its four sides burned in the Atlas Fire on the east side of Napa the first night of the wildfires, when winds were out of the northeast and gusting to over 70 mph. The east end of the structure featured wood framing to the ground, with a trellis above; once these ignited the rest of the structure was consumed.

“It looks to me that the plaster coated straw bale survived well until the wood part of the structure burned down. I wonder if the walls would still be intact if the plaster coating had covered the top of the wall as well. I think the straw burned after the top cap of the wall burned away and coal/embers dropped into the straw bales. To me the straw bale encapsulated in the plaster/concrete stood up well until the top was gone.”

David Arkin visited the walls on December 2, 2017, just prior to demolition, and observed that the PISE (pneumatically impacted stabilized earth) walls were still standing, and had been well bonded to the straw prior to the fire.
